## Living Lab Hedwige-Prosperpolder, a playground for training skills regarding emergency response

The realisation of managed realignment of the Hedwige-Prosperpolder at the Dutch/Belgian-border offered a unique opportunity to learn more about the strength of real dikes under simulated extreme conditions as well as to exercise with state-of-the-art emergency response tools and techniques. In this paper are presented on one hand the numerous destructive tests that have been executed on levee sections with presence of animal burrows, cliffs, trees, vegetation and on the other hand the organisation for emergency response in practice.

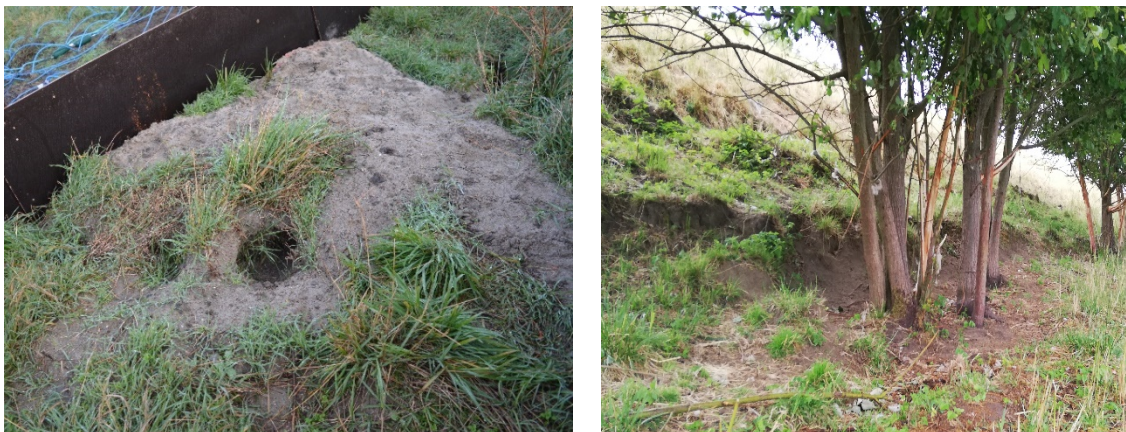
*Figure 1. Anomalies being tested under extreme loading conditions: animal burrows (left), (animal-induced) cliffs (right).*

Numerous destructive tests have been executed on levee sections with presence of animal burrows, presence of (animal-induced/artificial) cliffs, trees, vegetation indicating wet conditions, etc. (see figure 1).

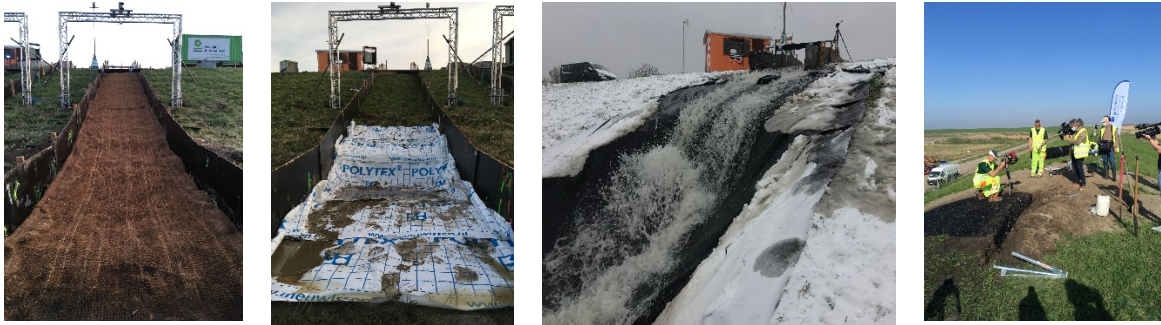
Figure 2. Repairing damage using Cocos mat, Tyvek, EPDM and reinforced turf mat.

In some cases, arising damage was repaired (see further) and these emergency measures were solicited again with continuous overflow or overtopping waves (see figure 2).

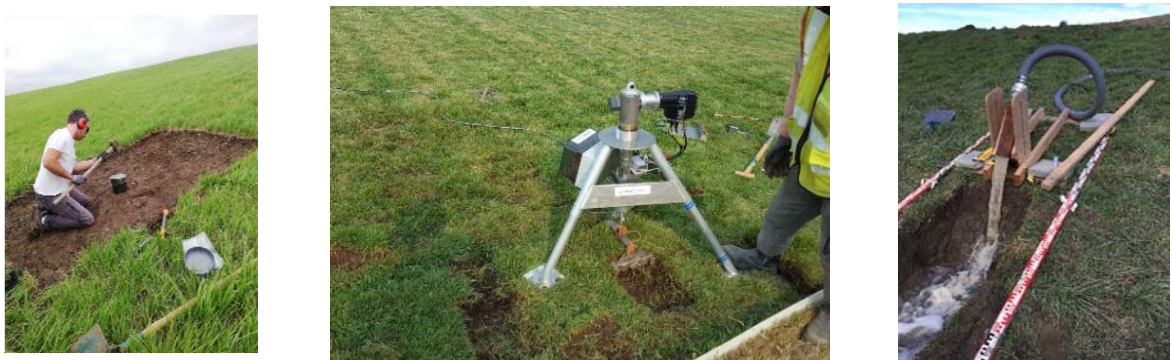
Figure 5. Sampling for JET-experiments (left), Grass Sod Pull test (middle), Fire Hose test (right).

In addition, portable devices were deployed for assessing erosion resistance, such as the Jet Erosion Test (JET), the Grass Sod Pulling Instrument and the Fire Hose Method (see figure 5).

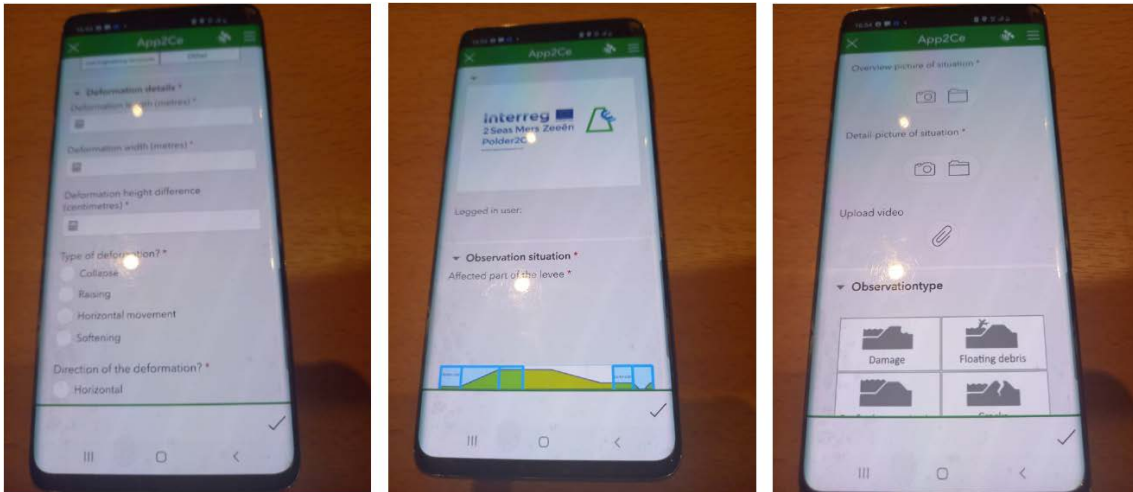
Figure 7. Newly-developed inspection app2C on smartphone.

The emergency response exercises were implemented for five main damages: local crest lowering, erosion holes or fallen trees, sand boils caused by piping, cracks due to slope instability and animal burrowing (fox holes). The Plan-Do-Check-Act, PDCA circle, started with observing and finding of damages during an inspection, making use of the newly-developed inspection app2C on smartphone. The levee app (see figure 7) was developed by ESRI to organize observing and inspection of levees for non-expert levee inspectors. The app enables levee guards to report damages, including the damage location, size and photos. Next, we focused on diagnosing and prognosis of the right approach, eventually leading to the execution of needed emergency measures. With the execution of emergency measures, we started observing again, closing the PDCA circle.

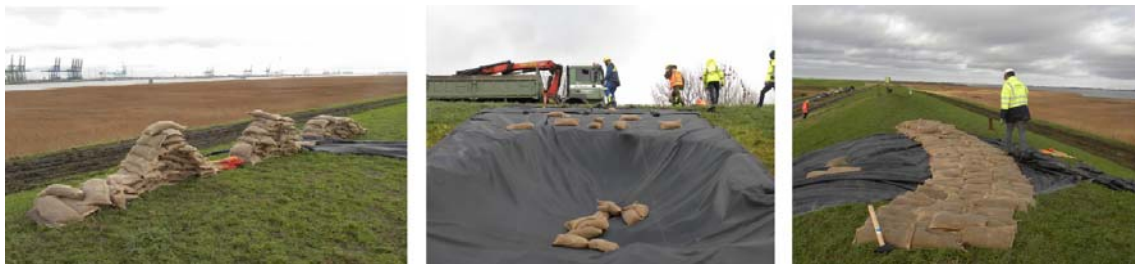
*Figure 9. Emergency response to repair the outer slope of a damaged grass covered levee.*

Groups of students were asked to repair the outer slope of a damaged grass covered levee in the Hedwige-Prosperpolder as well and efficiently as possible with their own innovative and durable protection measures. The temporary reparation of the levee (before later a permanent reparation) needed to be sufficient to withstand a series of wave overtopping generated with the wave overtopping simulator. The proposed emergency response in figure 9 required the use of geotextile and sandbags. For the very first-time rock bags were also used to repair levee damage in the Living Lab Hedwige-Prosperpolder.

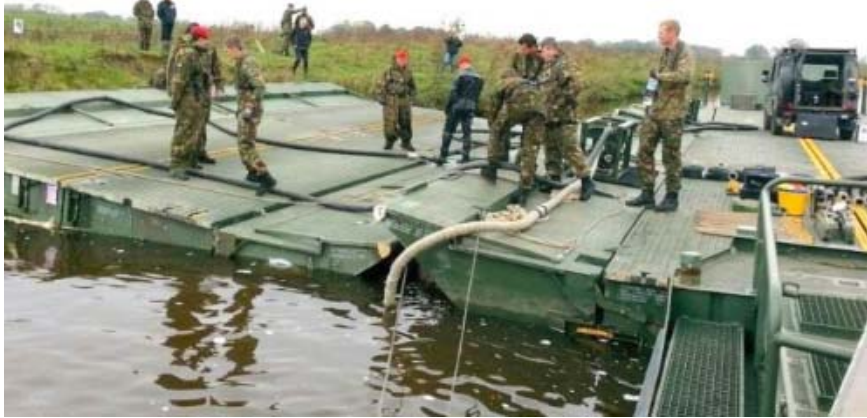
*Figure 10. Multifunctional military pontoon BreachDefender.*

If a levee breaches, accidentally or deliberately, it has to be closed as fast as possible. We explored different breach closure strategies under different circumstances, such as wide or small breach, high or low water velocity, accessible from land, water or air. We tested proven and innovative solutions such as a BreachDefender and mobile barriers. The BreachDefender (see figure 10) is a multifunctional military pontoon folding bridge being developed and tested by the Dutch Ministry of Defense. It can be used to stop or postpone the initial breaching process of a levee.

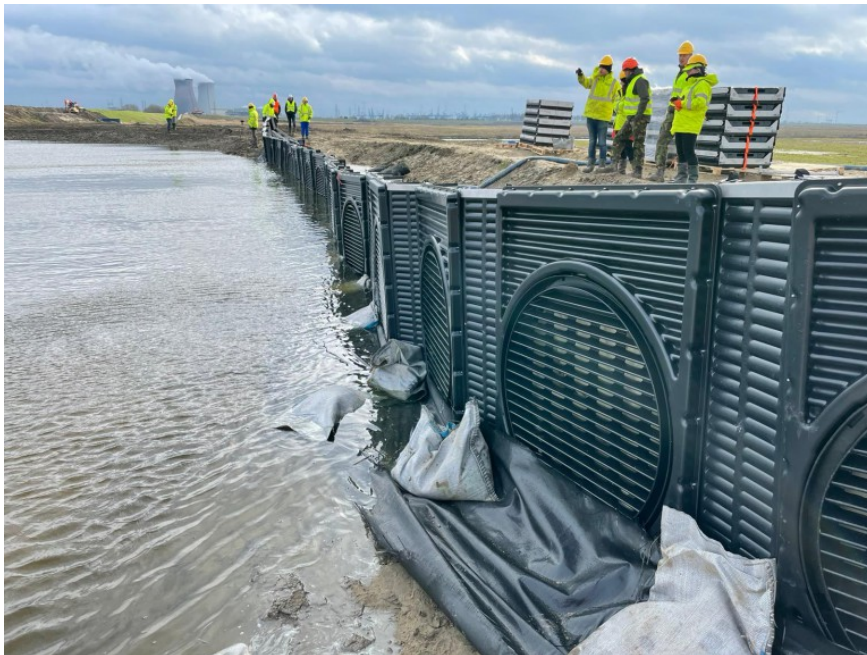
*Figure 11. Testing mobile barrier of Cuirassier in Hedwige-Prosperpolder.*

Another breach closure strategy consists in using mobile barriers. In February 2022 four types of mobile barriers were tested: Boxbarrier, NoFloods Flex wall, Mobiele dijken (mobile levee) and Cuirassier (see figure 11).

The tests were used to verify the main design criteria for the mobile barriers, namely the leakage rate, the mechanical stability to the water column and to the wind under different soil conditions, the possibility of laying with curvature or slope and finally the setup time.
