## **Erosional processes acting on coastal cliffs in the Split urban zone, Croatia**

*Mediterranean rocky coasts:  
Features, processes, evolution and problems*

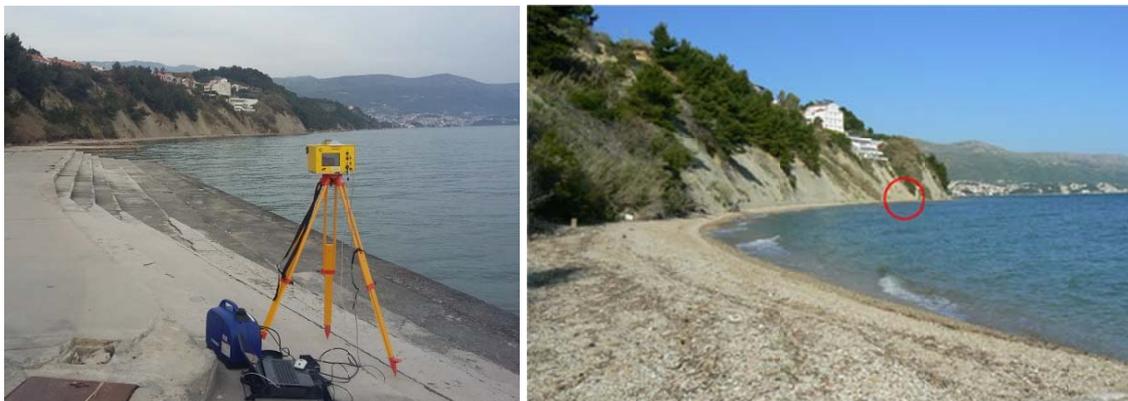
*Figure 1. Position of the TLS (left) and the conus like material (right, in red circle).*

The study site is a vegetation-free part of the ~30 m high coastal cliff formed in Eocene flysch assemblage (interbedded marl, siltstone, sandstone), located on the southern side of the Duilovo plateau in the Split urban area (figure 1). Flysch is a less prevalent rock assemblage along the carbonate-dominated Croatian shoreline and cliffs are a rare landform (PIKELJ & JURAČIĆ, 2013). Top of the studied cliff is an inhabited area, containing tourist and agricultural infrastructure, and threatened by ongoing erosion. In order to make an adequate erosion risk assessment in the future, this study aims, for the first time, to quantify flysch cliff erosion rate on the Croatian coast and to detect main erosional processes involved. To quantify cliff erosion, terrestrial laser scanner (TLS) was used.

Cliff-face morphology was scanned 8 times over 5 years (2012-2017) using the Optech ILRIS-3D laser scanner. The instrument was deployed each time on the 200 m distant concrete platform (figure 1) (detailed methodology is given in VLASTELICA *et al.*, 2016b). Trimble RealWorks software was used for point cloud construction and postprocessing. The first point cloud was georeferenced using orientation points determined by Trimble R8 GNSS receiver using CROPOS VPPS virtual reference station real-time kinematic (VRS RTK) positioning service. Horizontal and vertical accuracies were within 2 cm and 4 cm, respectively. The second scanning was done after 2 years, while other repeated surveys were conducted in 6 months interval. Subsequent point clouds obtained were georeferenced based on the first one using stable common surfaces (houses, platters, walls) visible on all point clouds. All point clouds were overlapped and four representative cliff profiles (P1-P4) on the vegetation-free cliff-face area of 1400 m<sup>2</sup> were chosen (figure 2) and compared to estimate erosional rates.

Cliff base is a sub-vertical (70-80°) slope, with a sharply angular transition to the beach (figure 1), where continued cliff retreat of rates between 7 and 18 cm/y was observed along all profiles and eroded material accumulates on the cliff toe (figure 3). Fine-grained part of this sediment is regularly removed by waves and transported offshore. Eventually, the sandstone rock fall occurs due to the bending of the exposed overhang (MIŠČEVIĆ & VLASTELICA, 2014), providing coarse-grained beach sediment, as

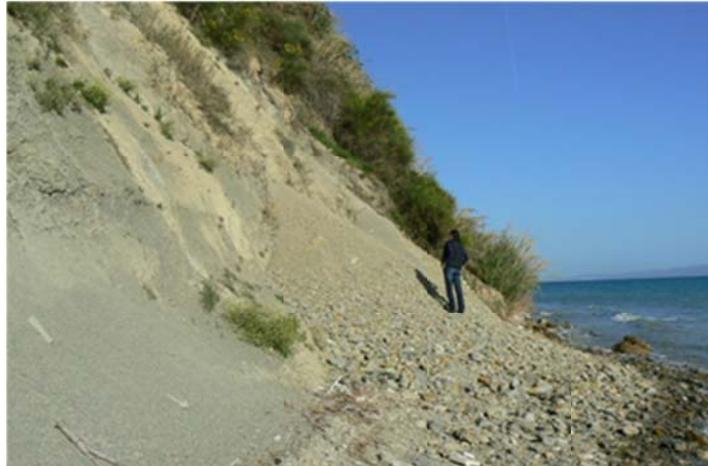
*Figure 3. Accumulation of the eroded material in form of the cone pile.*

In case of long-term and/or massive erosion, talus cone may form on the cliff toe (figure 3). Cone piles were recorded on the P2, where its emergence and disappearance occurred twice during the observed period. Such forms might be eroded between two surveys (as in case of surveys 7 and 8) or persist for a year (surveys 3 and 4).
